SUBJECT: Yellow Water Road Dump Superfund Site

Five Year Review Report

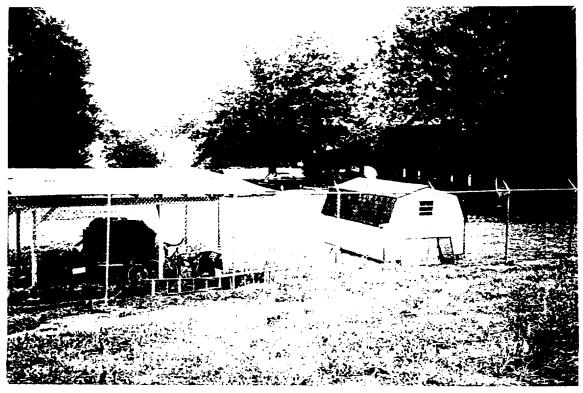
Photograph #6 June 27, 2000

Land use adjacent to the Site is a mixture of residential and undeveloped land. Adjacent to the monolith is a ranch style home and trailer (Photographs 5 and 6). Both of these units are occupied. It is understood that Ms. Hyman lives in the brick home and Mr. Robert Tyer Jr. lives in the trailer. No environmental damage was observed at the Site.

Description: Storage Sheds east of Monolith [facing east].

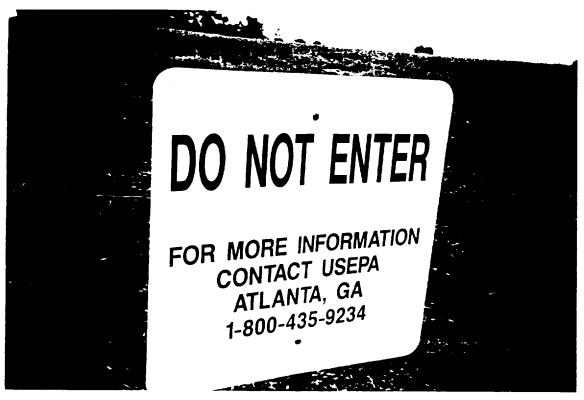
Photograph #7 June 27, 2000

As part of this Five-Year Review, several Site Inspection Reports were reviewed. These reports contain any problems encountered during the reporting period and the activities being taken to rectify these problems. During the first inspection, erosion occurred on the east face of the monolith, an exposed area was observed on the southwest corner of the monolith and distressed vegetation was noted throughout the fenced area of the Site. All of these items were repaired. At the second inspection weed growth was observed on several of the slopes of the monolith and a small tree was observed on the east slope of the monolith. Both the weeds and small tree were removed. Additional erosion on the north and east faces of the monolith was observed during the third inspection with other minor vegetation problems. After corrective actions were performed, there have been no maintenance difficulties other than providing a vegetative cover that can withstand severe weather conditions (i.e., drought conditions). Warning signs posted within the Site security fence were replaced. These signs contain the revised language suggested by the USEPA in a letter dated November 1, 1999 (Photograph 7).

Description: Warning Sign.

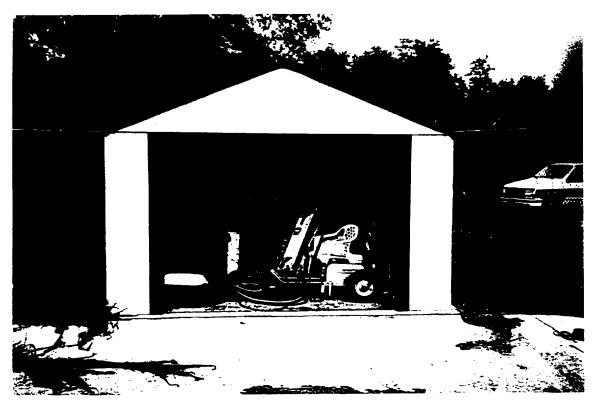
Photograph #9 June 27, 2000

The Site has been restored to its pre-construction condition with the exception of the newly constructed monolith. The monolith measures approximately eight feet in height at the highest point and covers an area of approximately 1.3 acres. Photographs 1-5, 21 and 22 show portions of the monolith. A permanent equipment decontamination pad was constructed at the eastern entrance to the fenced area and is adjoined by an aluminum maintenance shed and polyethylene tank (Photograph 8). The maintenance shed houses molded samples of treated soil material, monitoring well sampling equipment and other supplies. Photograph 9 shows the equipment in the storage shed.

Description: Equipment in Storage Shed.

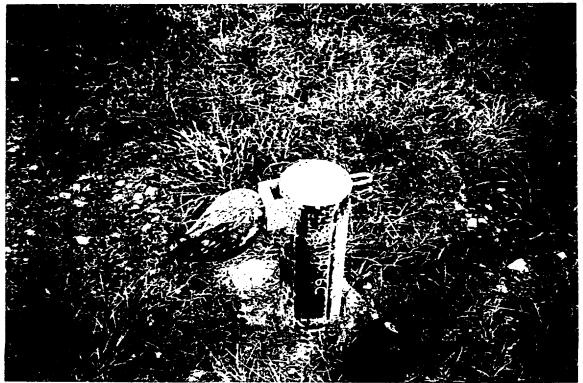
Photograph #14 June 27, 2000

Description: Monitoring Well MW-6C Grouted.

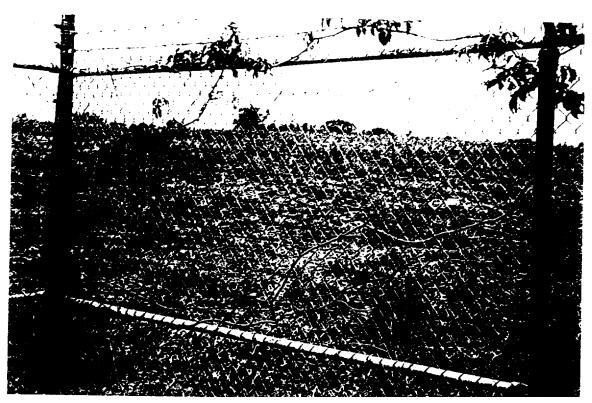
Photograph #17 June 27, 2000 Location: Yellow Water Road Superfund Site, Duval County, Baldwin, Florida.

dead. Most of these barren areas are located on the side slopes of the cap where there is a greater potential for erosion effects. Photographs 2, 5 17, 21 and 22 illustrate some of these barren areas. The grasses within the fenced area and outside of the fenced area appeared to have been recently mowed. No trees or shrubs with deep-penetrating roots were observed on the monolith although there was evidence of dead trunks approximately 3 to 4 inches in diameter along the fence line (Photograph 19). A herbicide appears to have been applied along the fence line as there is no vegetation along either side of the fence line. There was minor evidence of erosion along some of the side slopes. This erosion has been mitigated by the use of geoweb material (Photographs 17 and 18). Photograph 20 shows a borehole created by some animal by the fence line. Mr. Clegg stated that this borehole will be grouted during the site inspection and has since reported that this task has been completed.

Description: Northern Side of Monolith with Geoweb Material Shown in Middle of Photo.

Vegetative Cover. Purchase a mixture of grass seed in accordance with design requirements as noted on Table 4 and apply this seed mixture in barren areas with an erosion control mat or mulch during the semi-annual inspection. Continue to sew grass seed in barren areas during subsequent inspections.
